Dam Removals

A Discussion of Issues and Impacts

*ASCE Joint Conference on Water Resources
Engineering, Planning & Management
Minneapolis, MN 2000*

Appleton Mill Pond Dam Removal Case History

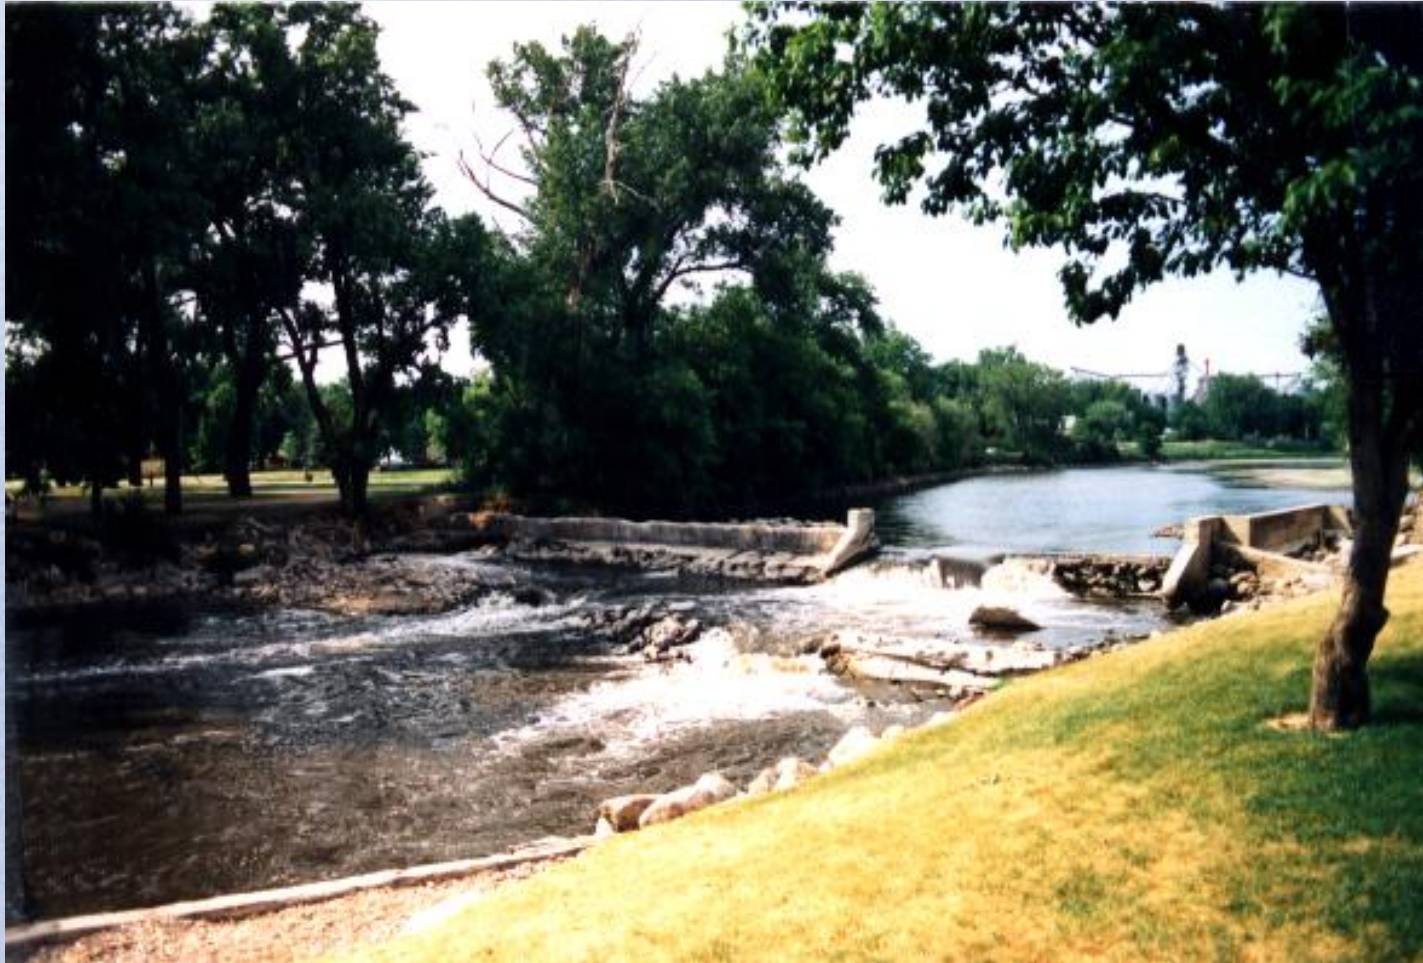
Appleton Dam Before Removal

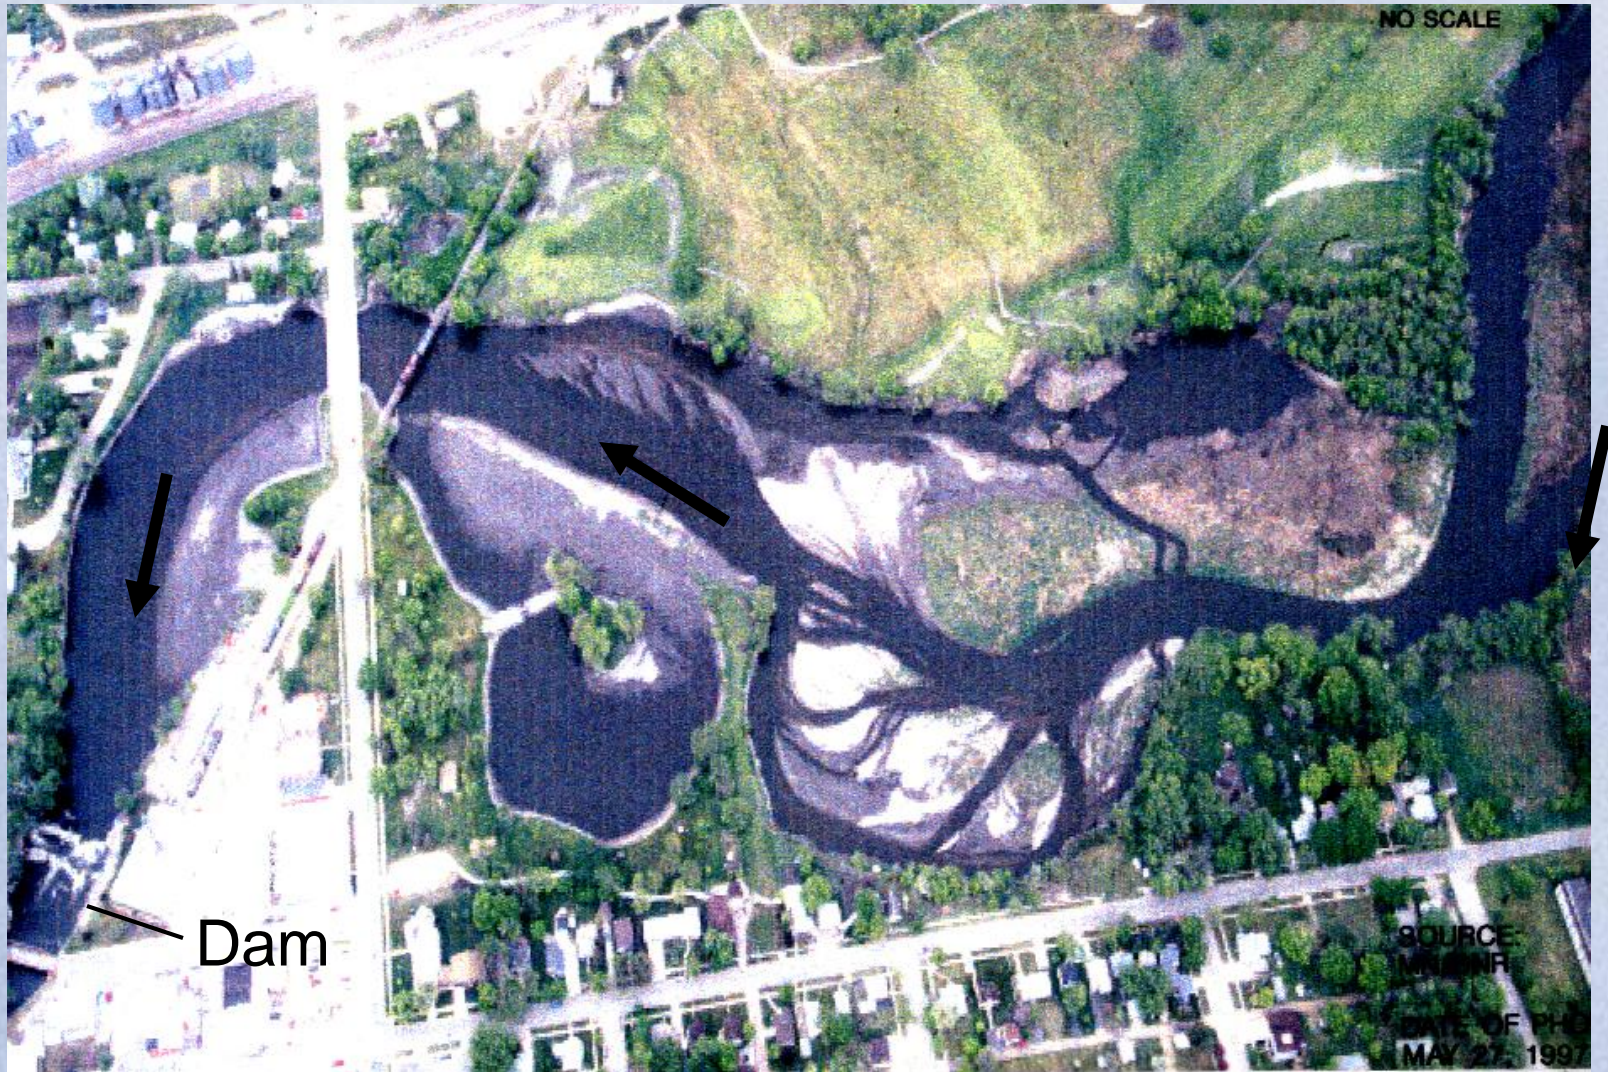
Aerial Photo of Appleton Dam's Pool

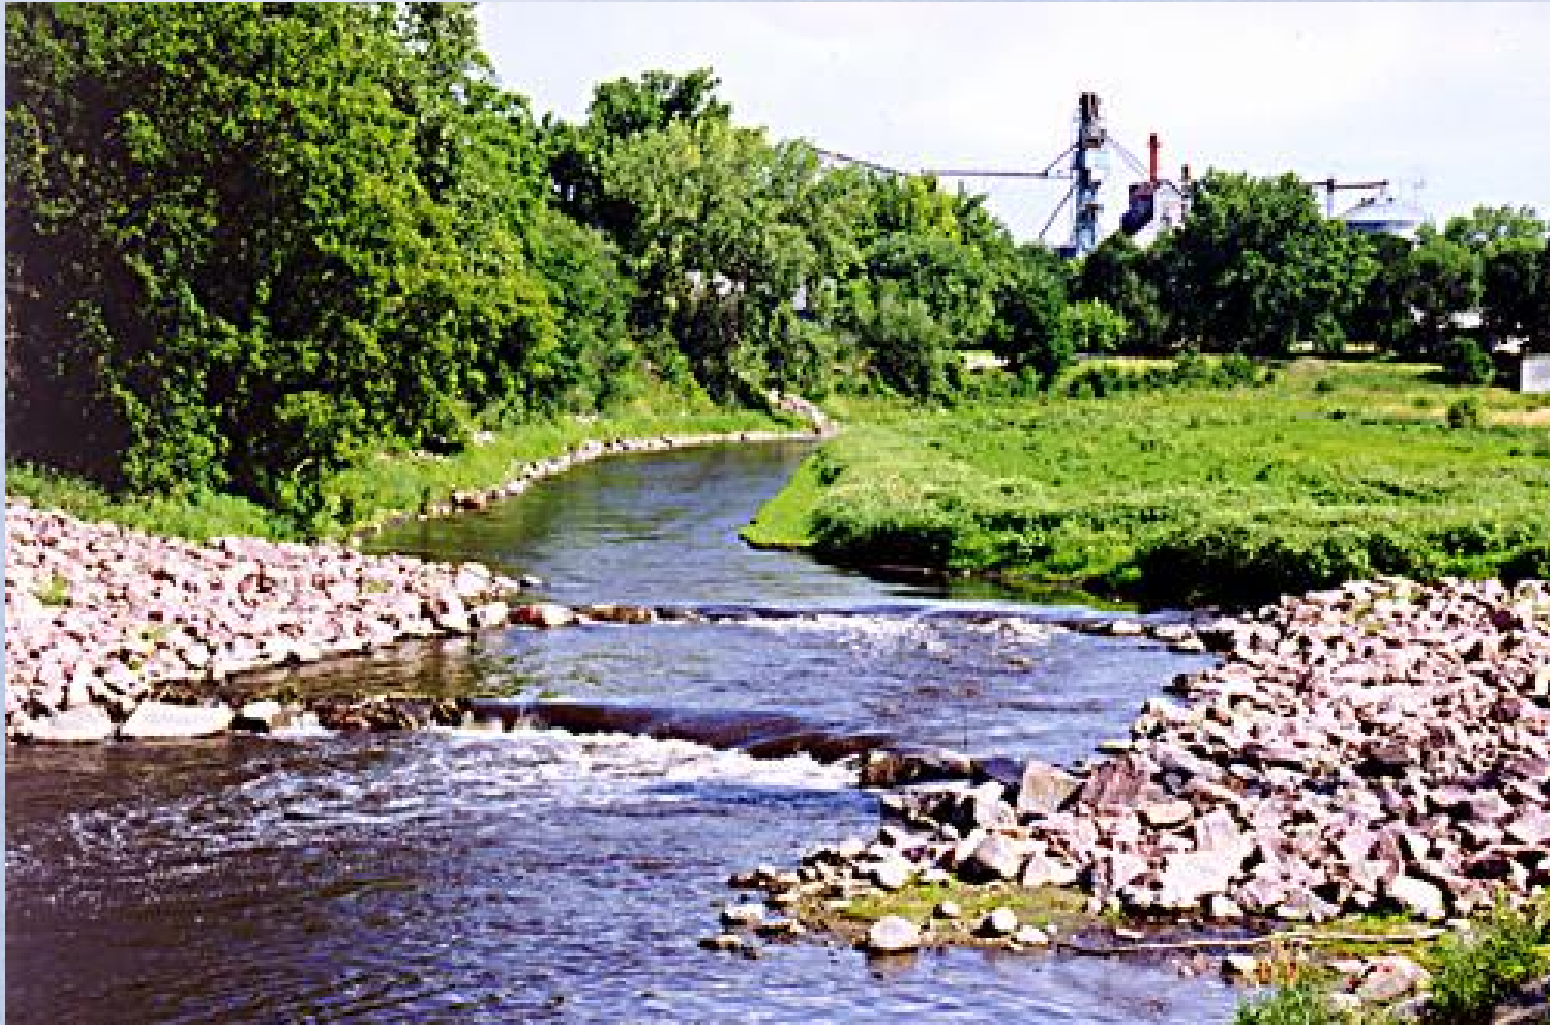
Appleton Dam After Removal

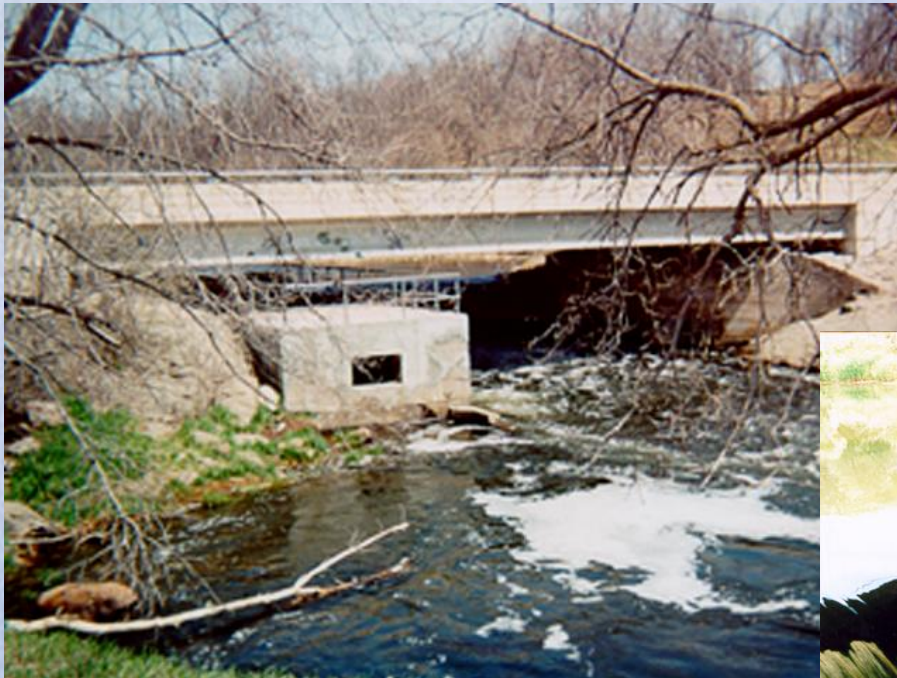
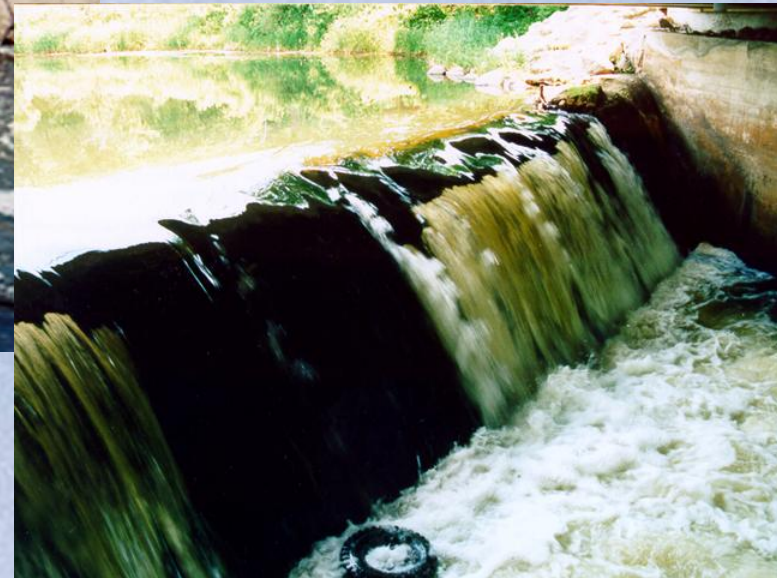
Frazee Dam Before Removal

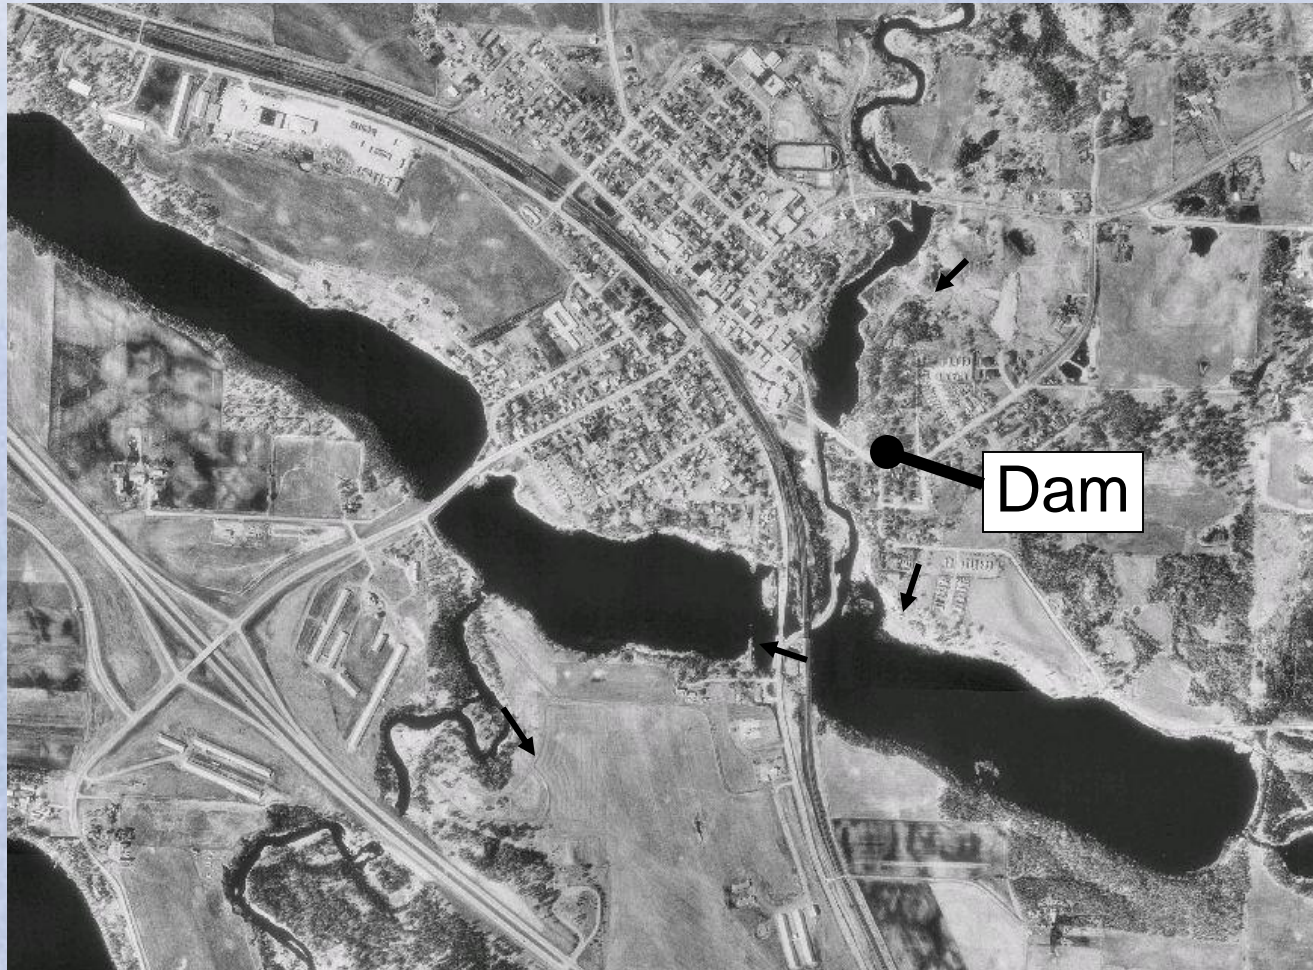
Aerial Photo of Frazee Dam Pool Before Removal

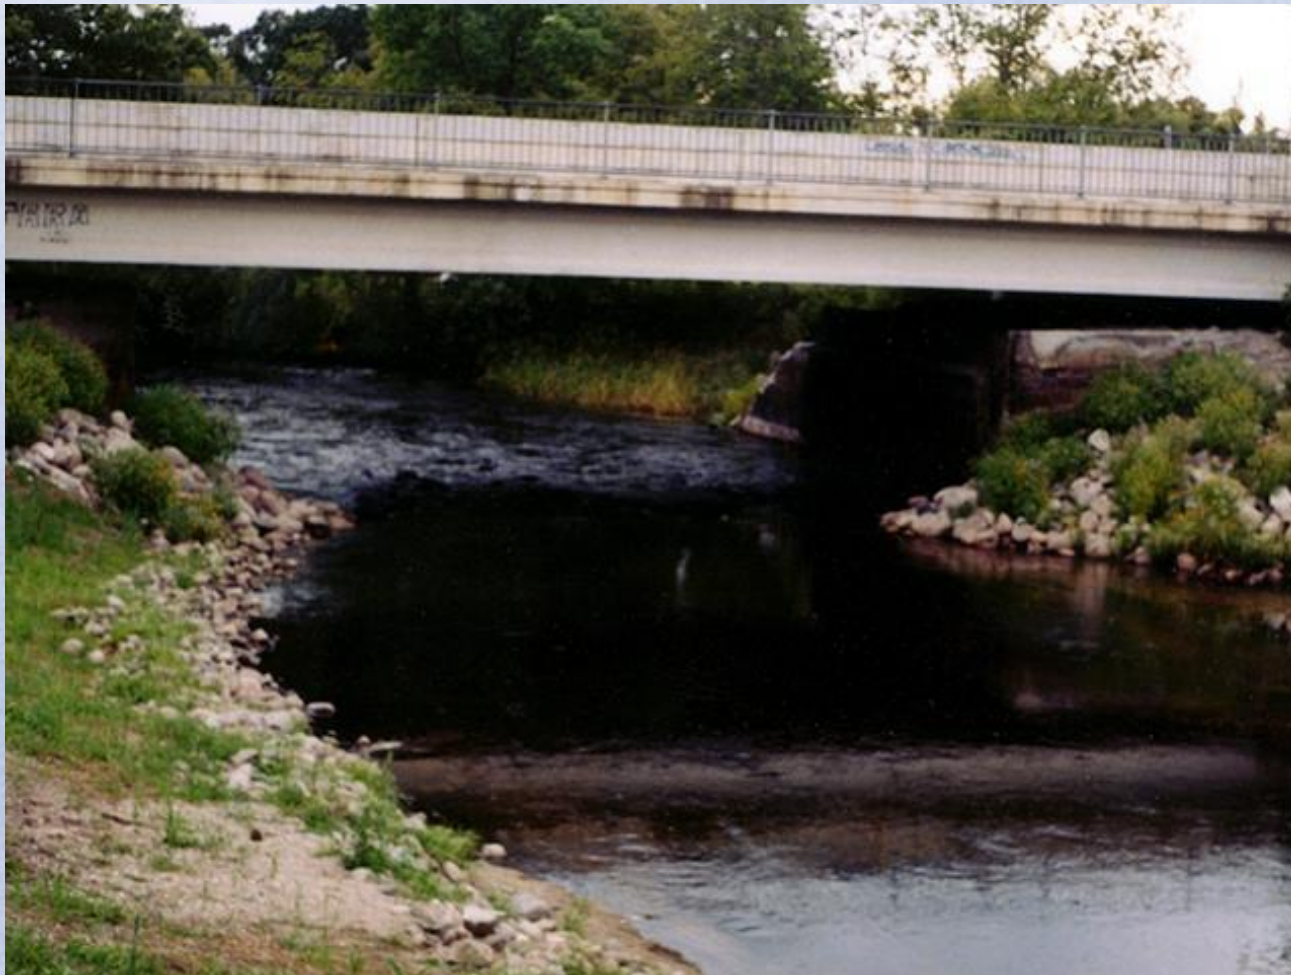
Frazee Dam Site After Removal

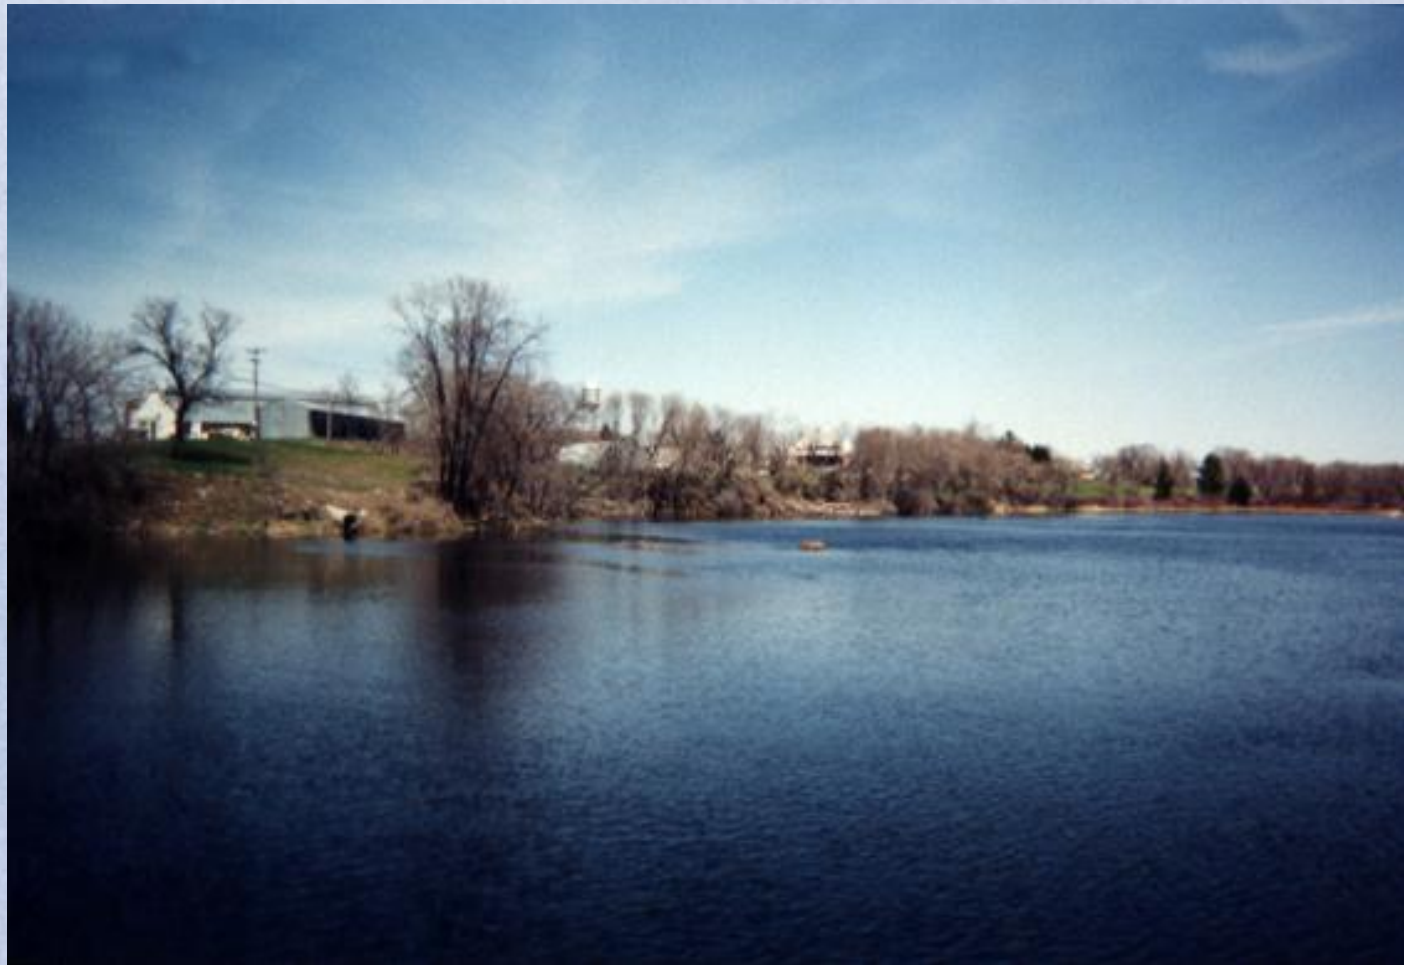
Progression of Frazee Pool *Spring Before Removal*

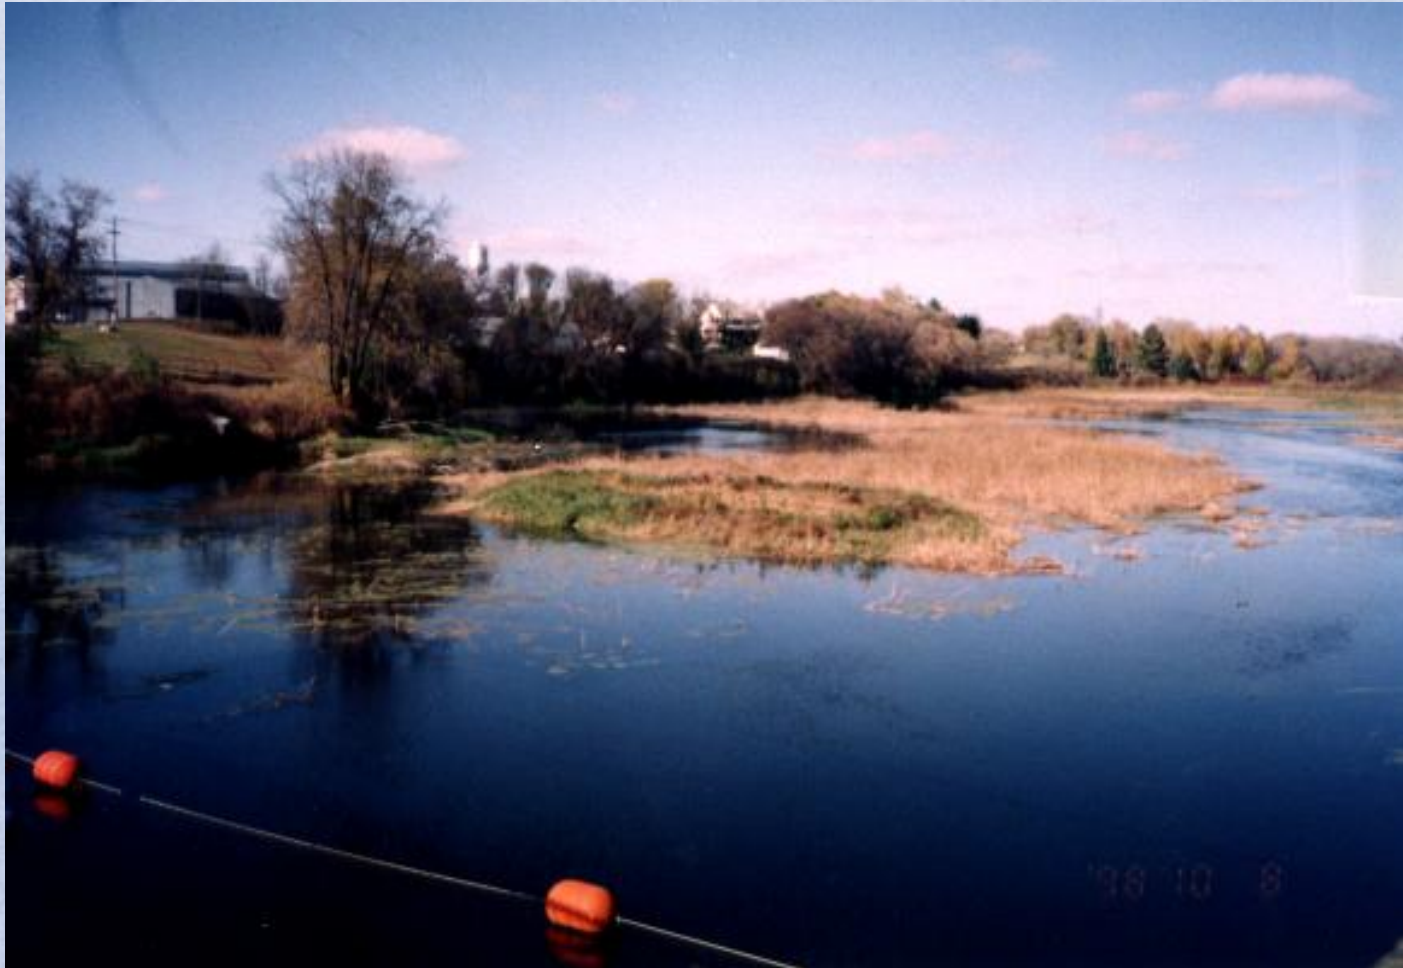
Progression of Frazee Pool *Fall Before Removal*

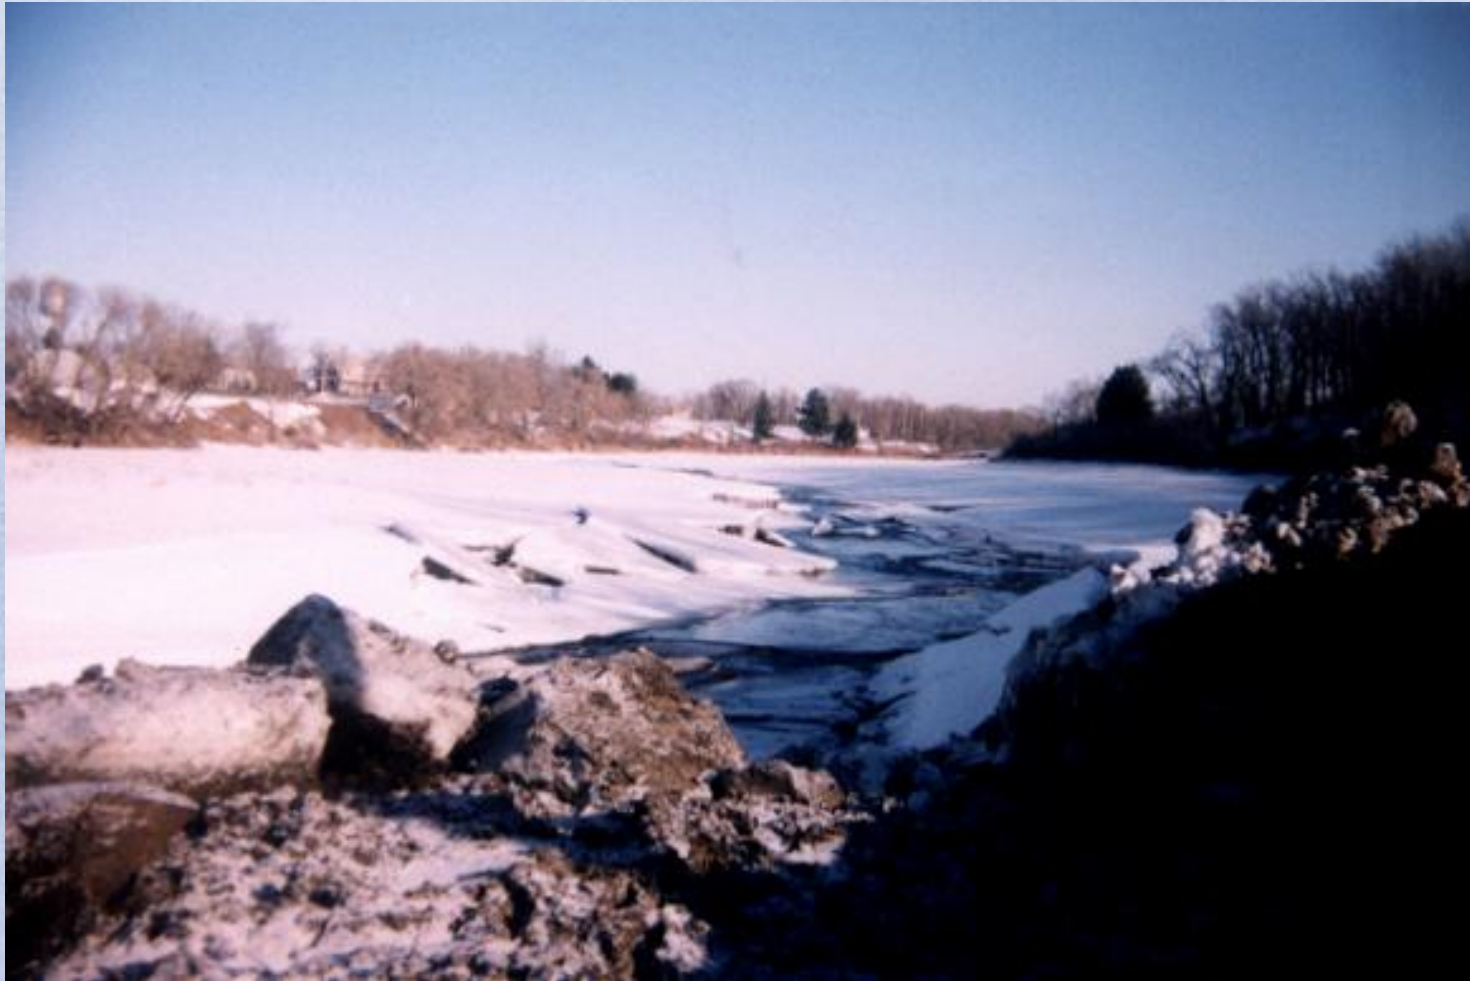
Progression of Frazee Pool *Winter During Removal*

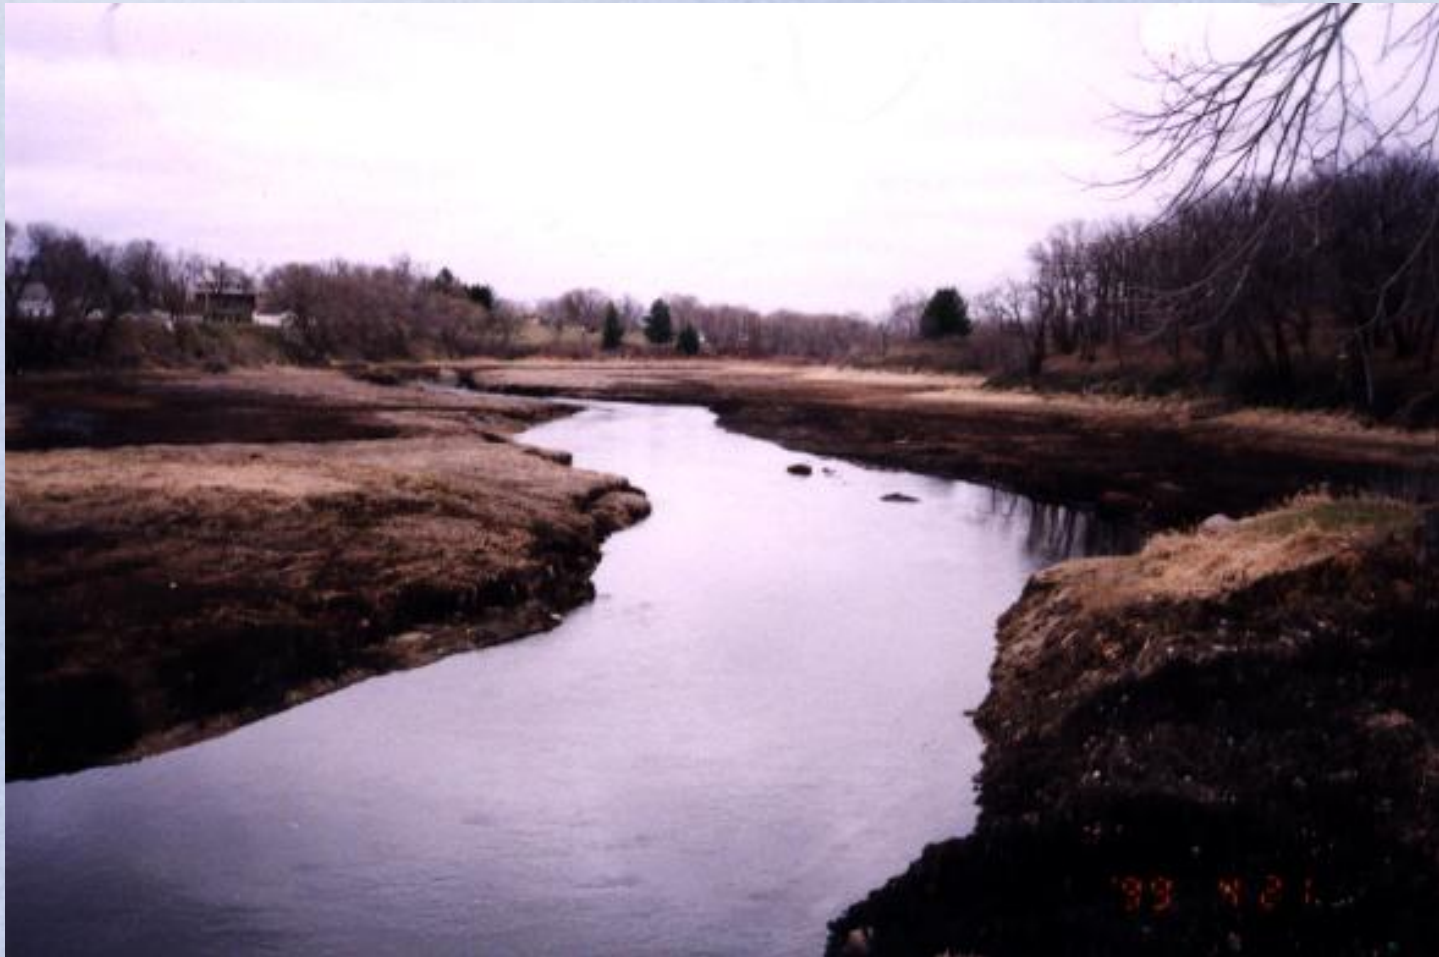
Progression of Frazee Pool *Spring After Removal*

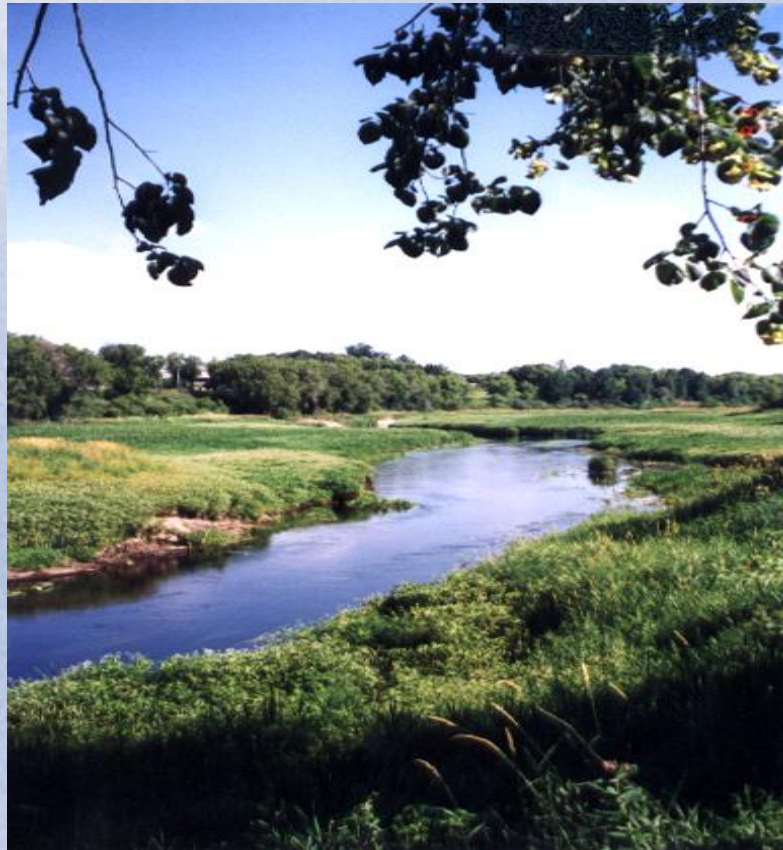
Progression of Frazee Pool *Summer After Removal*

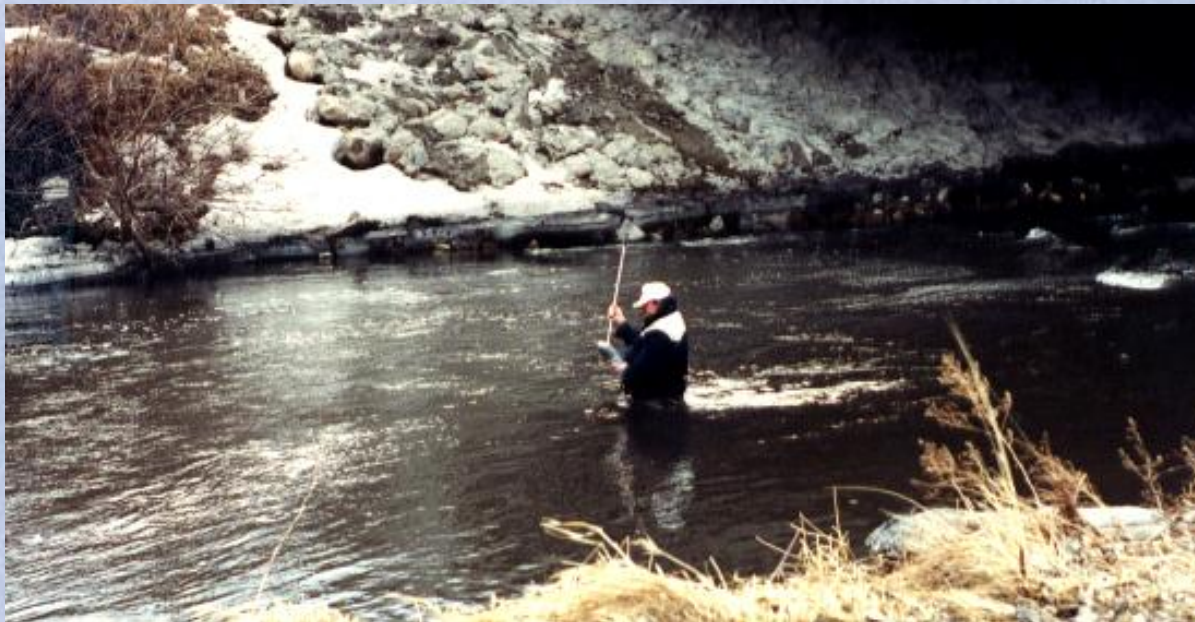
Impact of Dam Removal on Water Quality Was Measured

- Total Suspended Solids (TSS) Concentrations were Measured Using a Depth Integrated Sampler

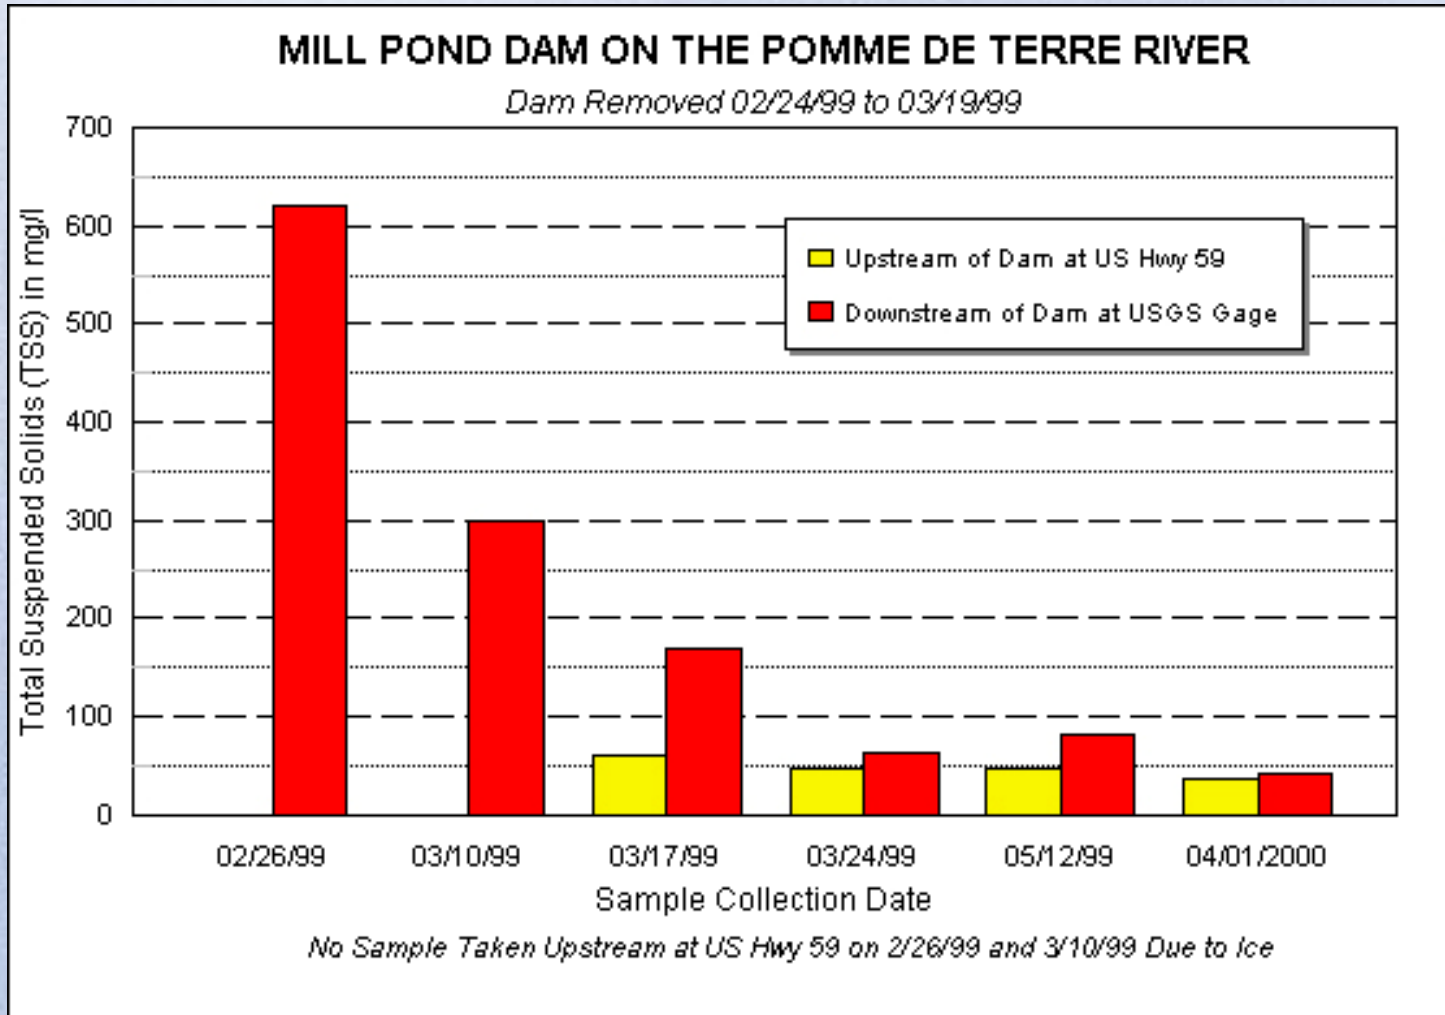
Results of Water Quality Sampling

- Dam Removal is Gaining More Attention as an Alternative to Repair and/or Reconstruction
- Engineering Considerations are Part of the Removal
- Planning Considerations are Part of the Removal
- The Physical Conditions After Removal Must be Fully Explored when Considering Removal (Not Only What's Lost)
- Measured Values During Two Dam Removals Indicate the Impact to In-Stream TSS Concentrations are Short-Term and Stabilize Quickly After the Removal

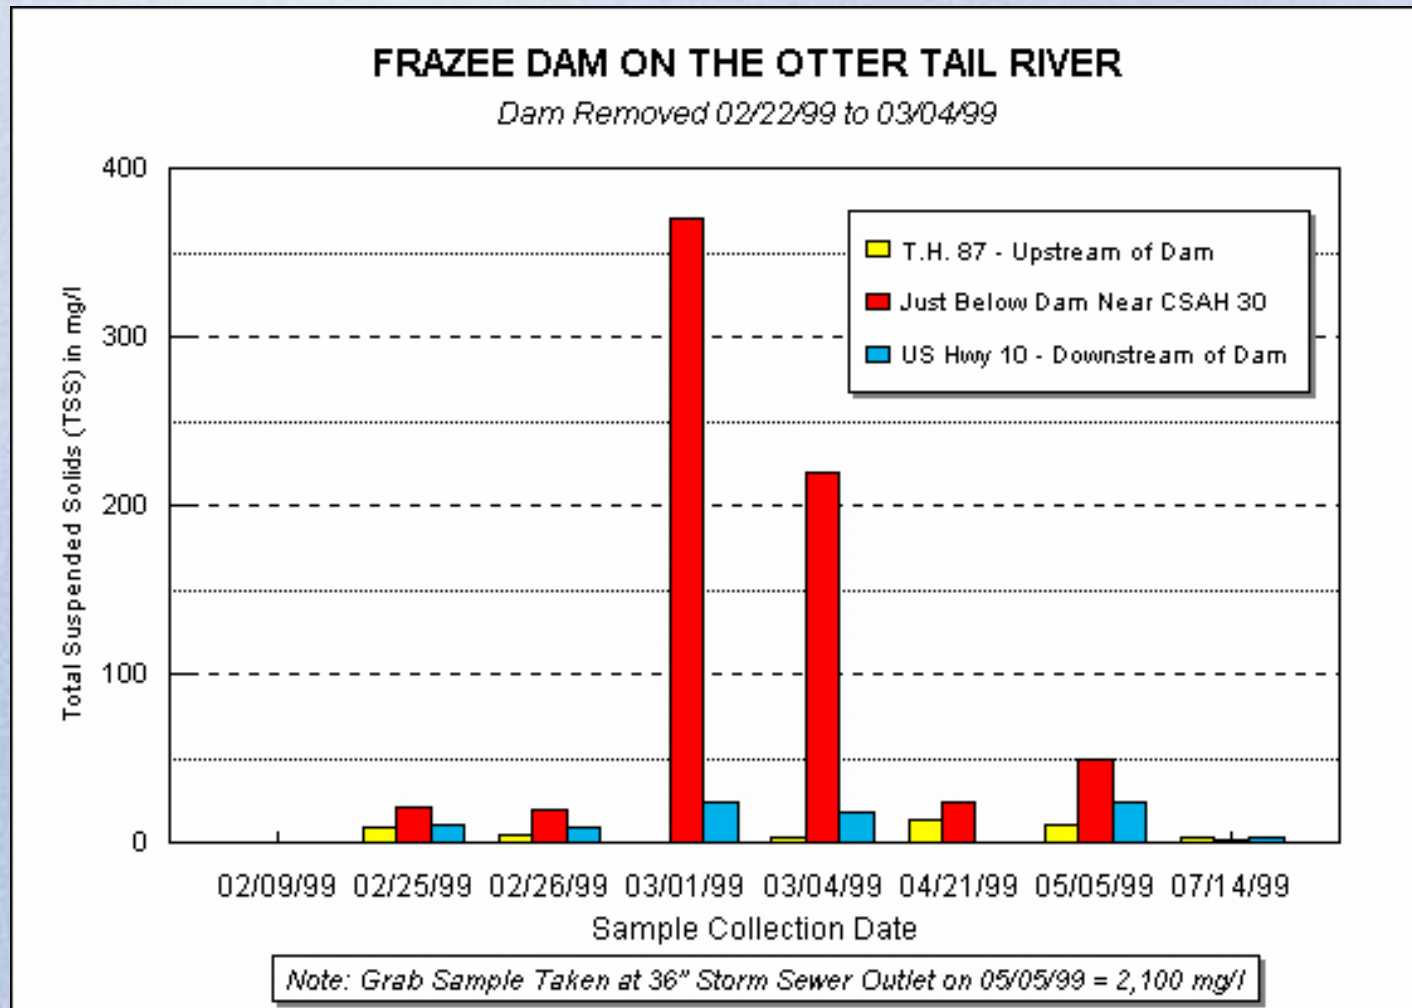
Results of Water Quality Sampling

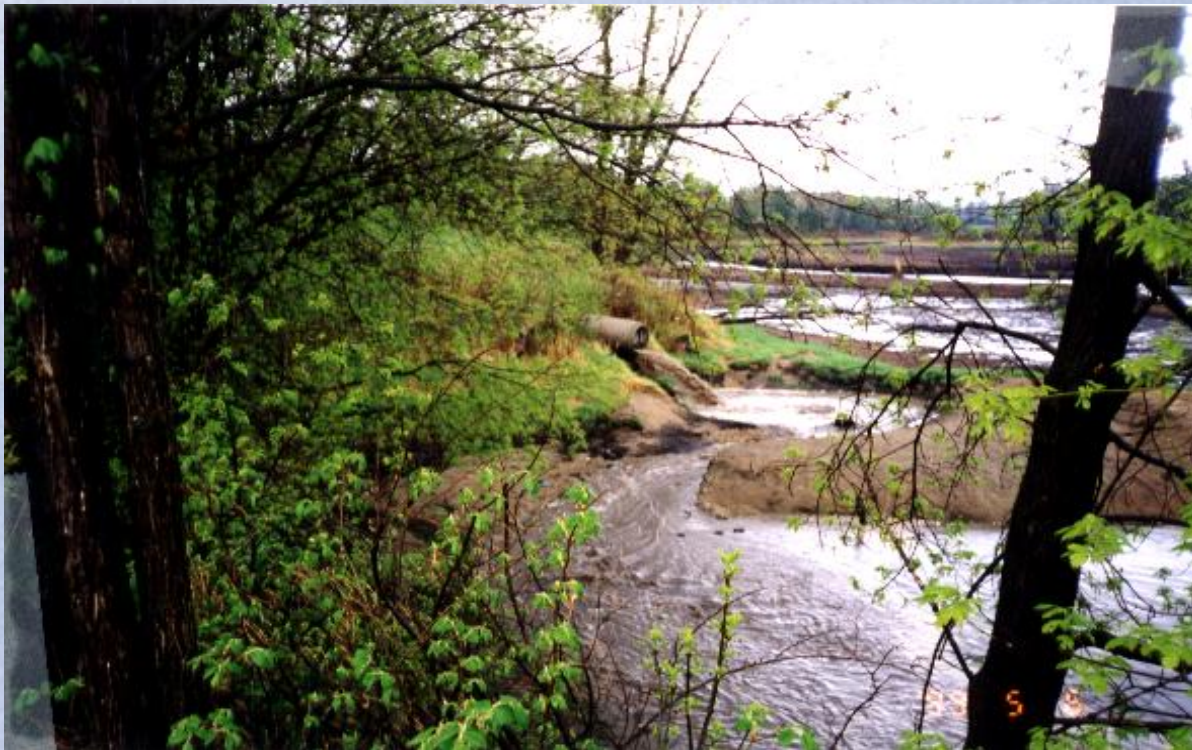
Comparison of Measured TSS Values

- A Grab Sample Taken At Frazee (2,100 mg/l)
